in my case the linkage detached from the actuator

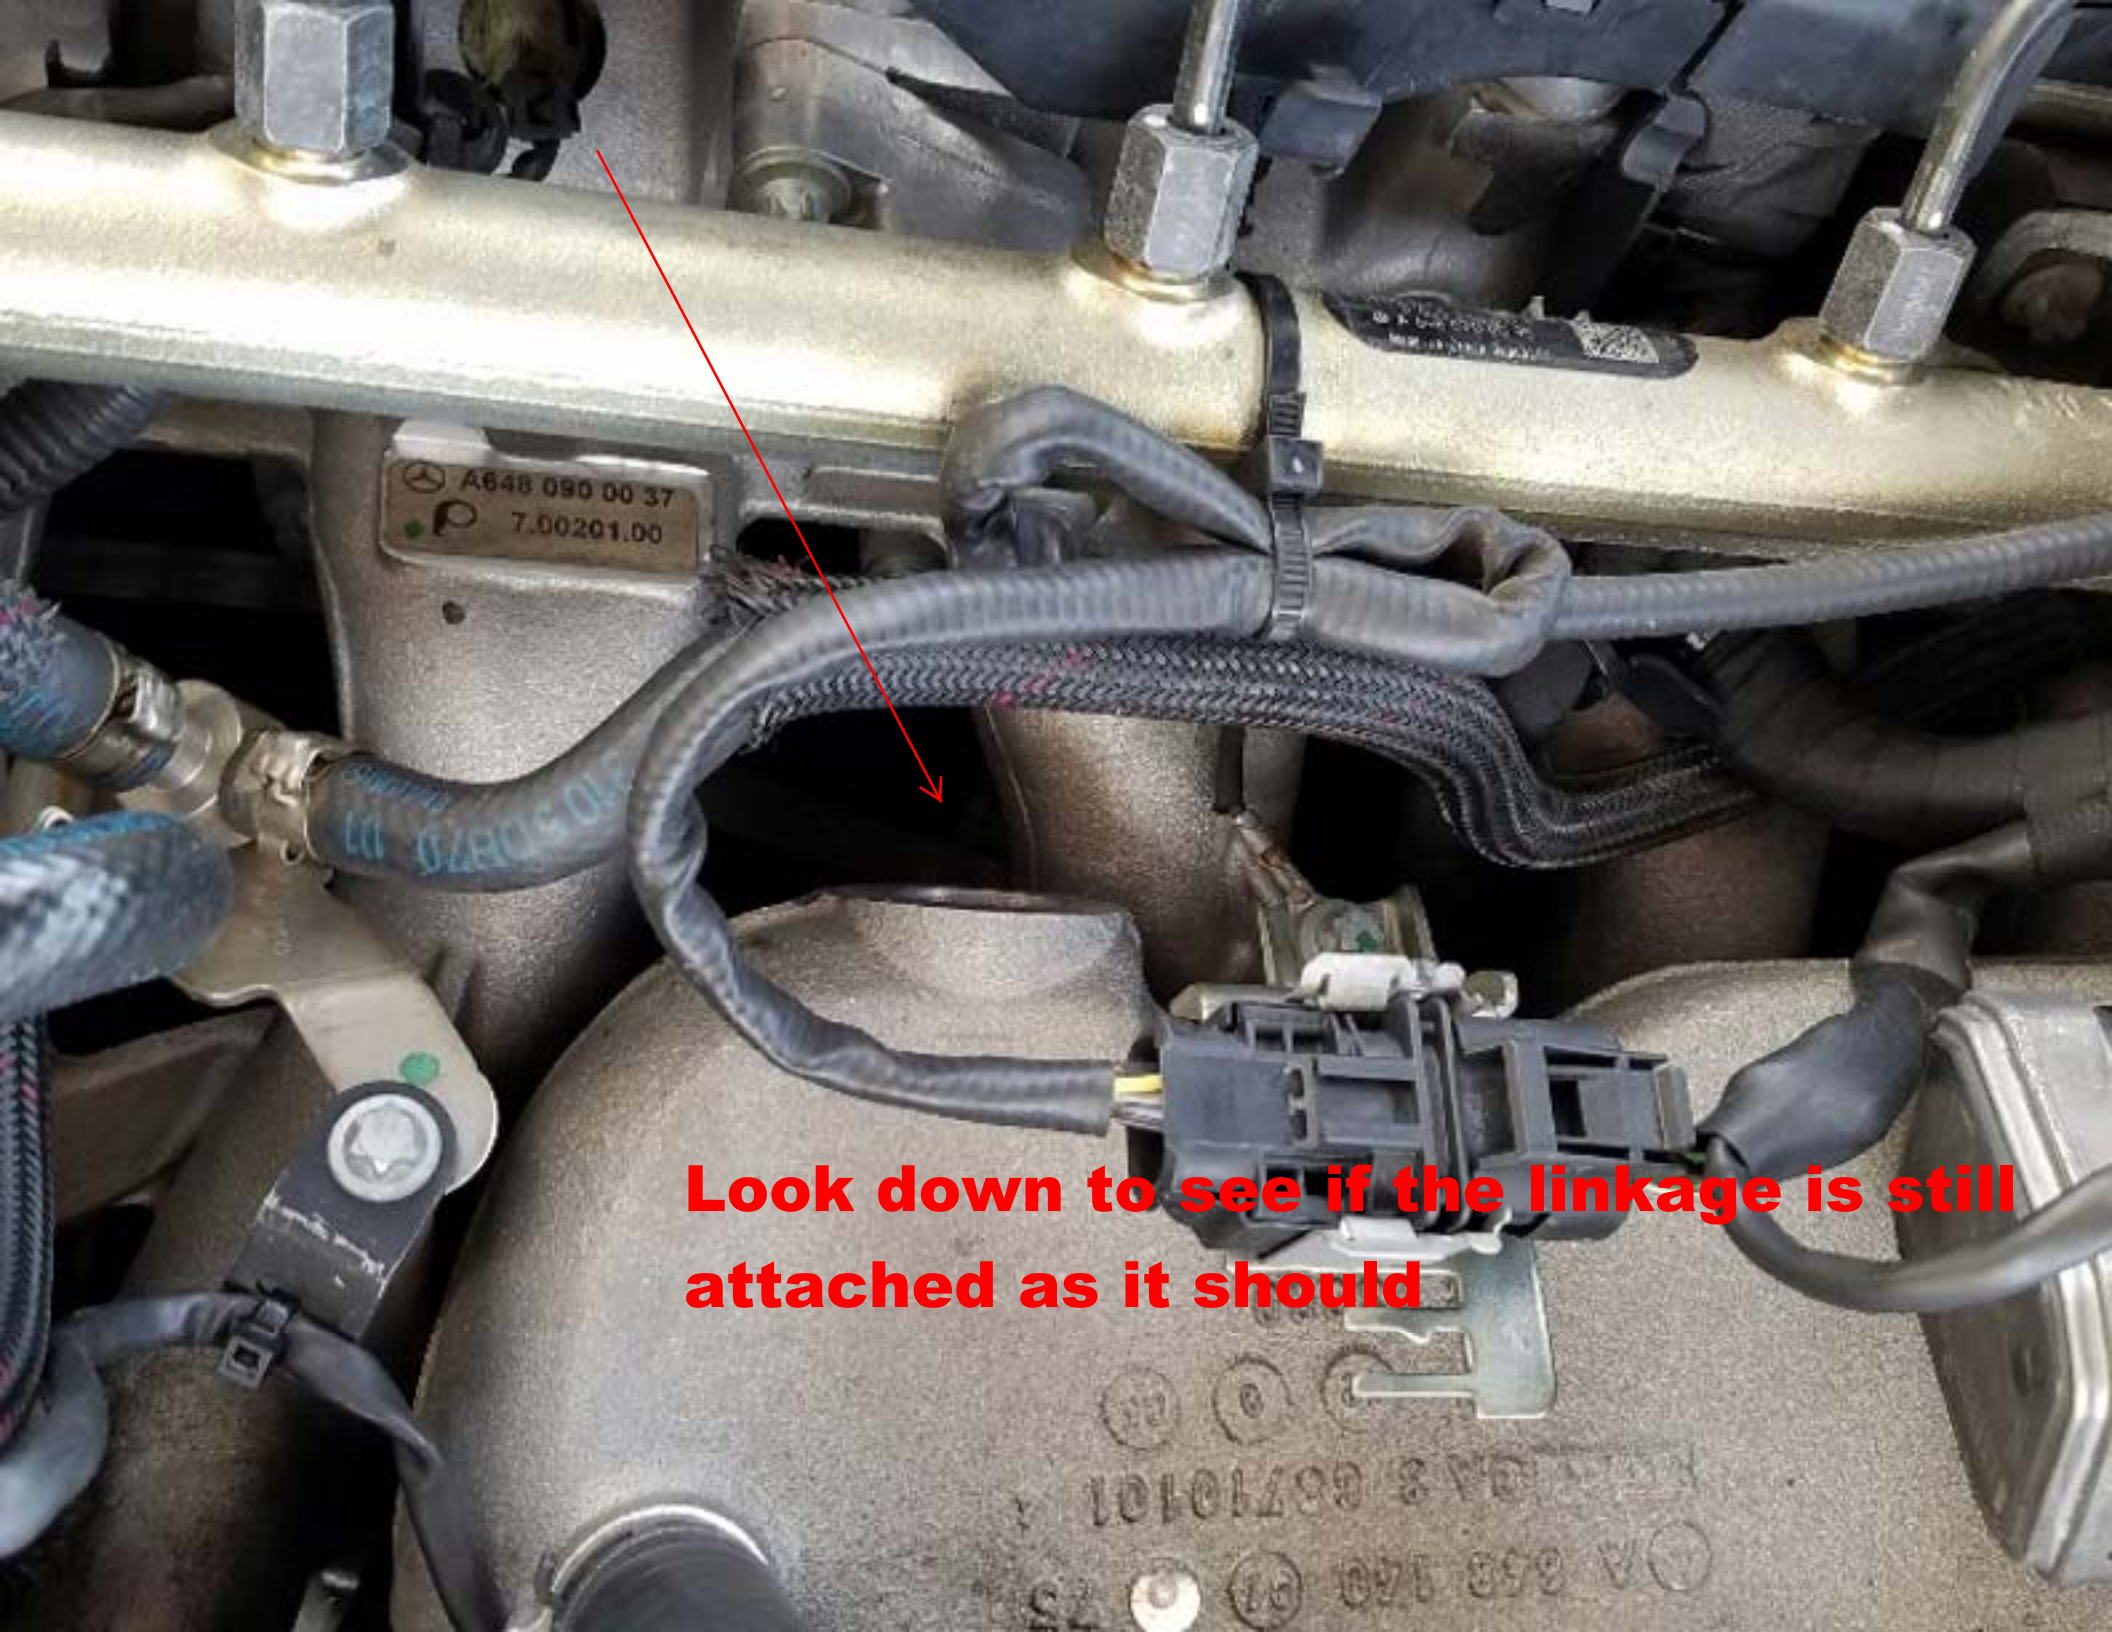
Look down to see if the linkage is still attached as it should
