Complaint:

Sluggish acceleration when engine cold up to about 2000 rpm

Engines 602.96, 603.96

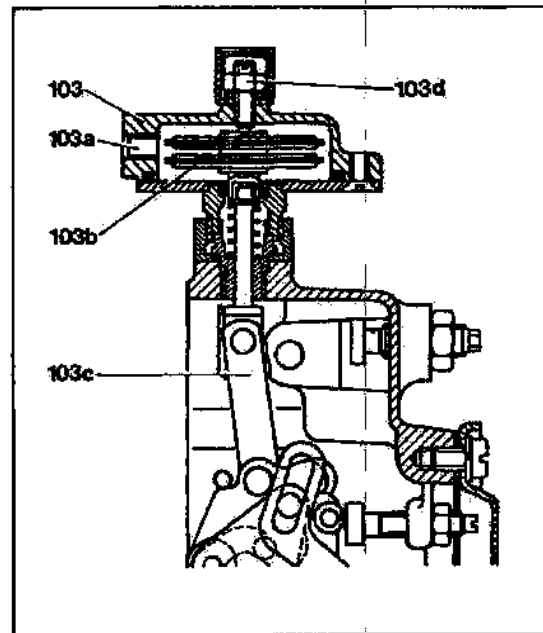
P07.11-0003-02

- a) Full load stop not correctly set.
- b) Insufficient full load quantity.

- a) Check setting of accelerator control linkage, adjust (see RA30-1010).
- b)
  - 1 Remove boost air pipe, install (see RA14-1310).
  - 2 Set full load quantity at barometric pressure compensation unit:
    - Take off cap (black) on barometric pressure compensation unit (103).
    - Slacken lock nut (103d).
    - Use a screwdriver to turn setting screw about 1/4 turn to the left.
    - Tighten lock nut (103d).
    - Fit on cap.
