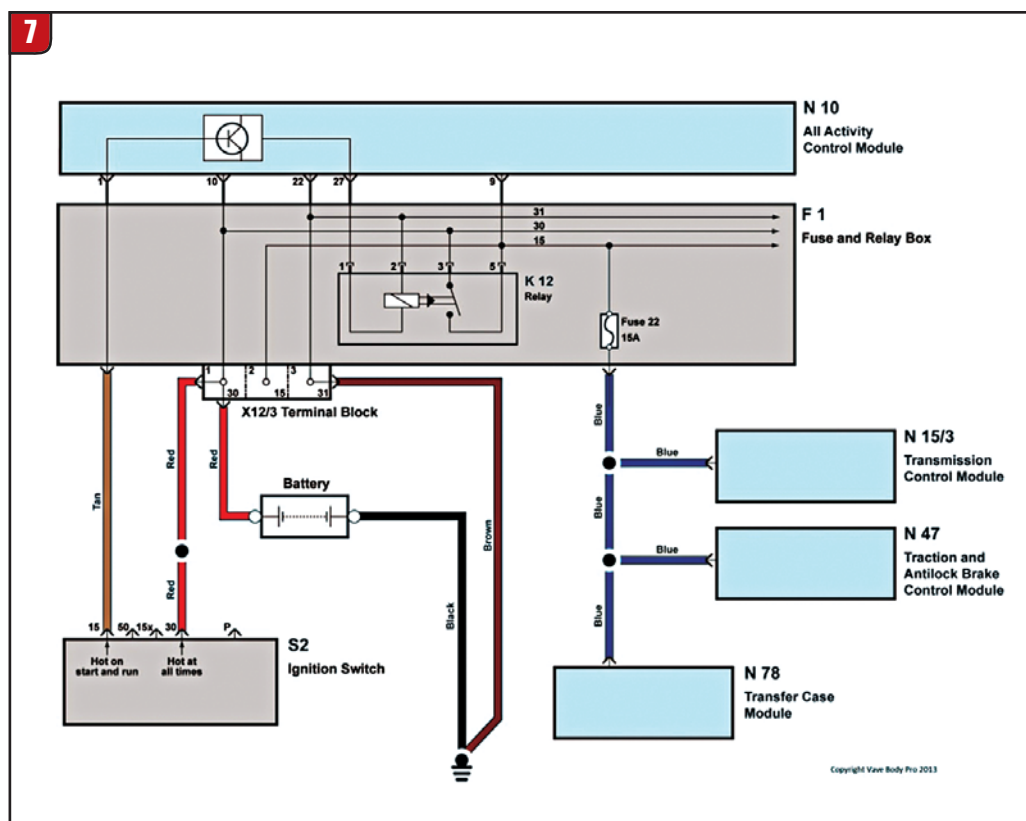
A close look at the wiring diagram (Figure 7) led us to suspect the K12 relay, and after more voltage-drop checks we found relay K12 to be defective. The relay would fail at times to turn on and supply voltage to circuit 15, which feeds fuse F22, which in turn provides voltage to the transmission control module (N15/3), transfer-case module (N78) and ABS module (N47). With these modules not turned on, no speed-sensor information was provided to the TCM, so the transmission would not shift.
