AF91.10-U-2101A	Front seat cushion has insufficient side support when driving through turns, front seat cushion cover damaged in the area of the seat cushion adjustment knob	29.4.97
-----------------	---	---------

MODEL 124

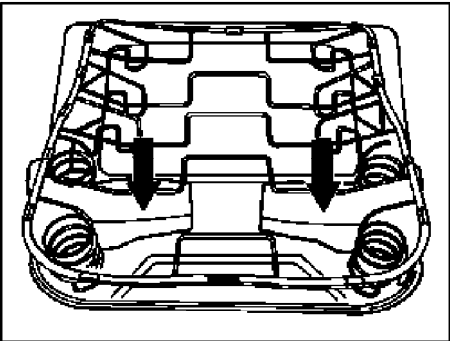
P91.10-0544-01

Damage Code	Cause	Remedy	
No Code	<ul style="list-style-type: none"> <li>Insufficient side support of seat cushion frame.</li> <li>With extreme weight on the front seat, the seat cushion cover can be pinched at the front seat tilt adjustment mechanism.</li> </ul>	1    Install two foam block to the seat cushion padding on the left and right side between the two front springs. Part No: 124 910 16 75
