**DTB**

Date: May 25, 2007  
Order No.: P-B-83.00/102  
Supersedes:  
Group: 83

**SUBJECT: Model 211.026/056/070/083/087/256/283/287  
Equipped with Code 580 Two Zone Climate System Option (ACC)  
From VIN A845370 to B100720 and X189946 to X223159  
Reduced Air Flow / Cooling from Climate System After Long Drives**

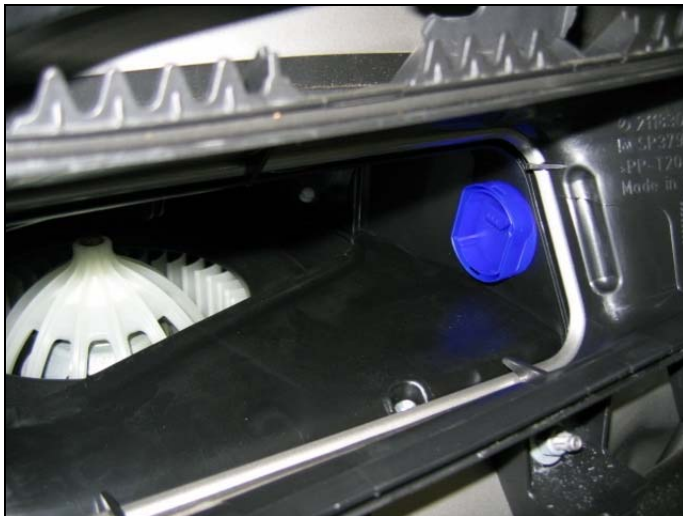
Figure 1

1. Verify that the vehicle does not have a humidity sensor installed by removing the climate system air intake filter housing. A blank plug should be visible on the right side of the air intake (Figure 1).

2. Remove the blank plug by twisting it approximately a quarter turn and releasing it from the housing. Release the harness connector from the blank plug.
3. Plug the harness connector into the humidity sensor (A211 830 05 72) and install sensor into housing. Install climate system air intake filter housing.
4. Using SDS change the version coding: Workshop coding → B31/2 (Air humidity sensor) → Change from Not Present to Present.
5. A system slightly undercharged can cause the evaporator temperature to get too low and contribute to this condition. Verify that the air conditioning system is fully charged by evacuating and re-filling the system to the correct level. Refer to WIS document AR83.30-P-5251P.
