Mercedes 722.6: Cold Stall/TCC Shudder, Part 1

Ed Lee

May, 2010

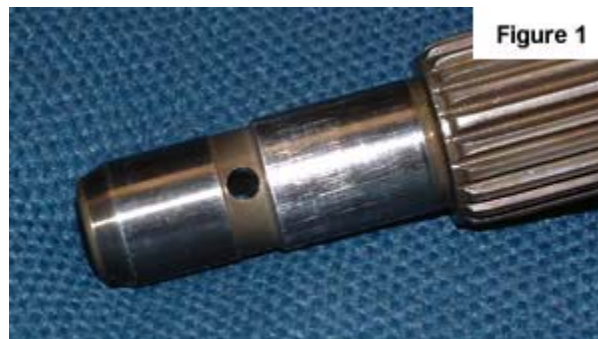
Figure 1

The Mercedes 722.6 converter uses a clutch pack to provide TCC clamping force and a three (3) path converter oil circuit. One path is for converter charge oil to enter the converter and another is for lube oil to exit the converter. The third circuit is used to provide TCC apply oil pressure during lockup or to allow apply circuit oil pressure to exhaust when the TCC is released. The apply oil travels through the input shaft and exits between the smaller and larger diameters of the smooth areas at the end of the shaft (Figure 1).

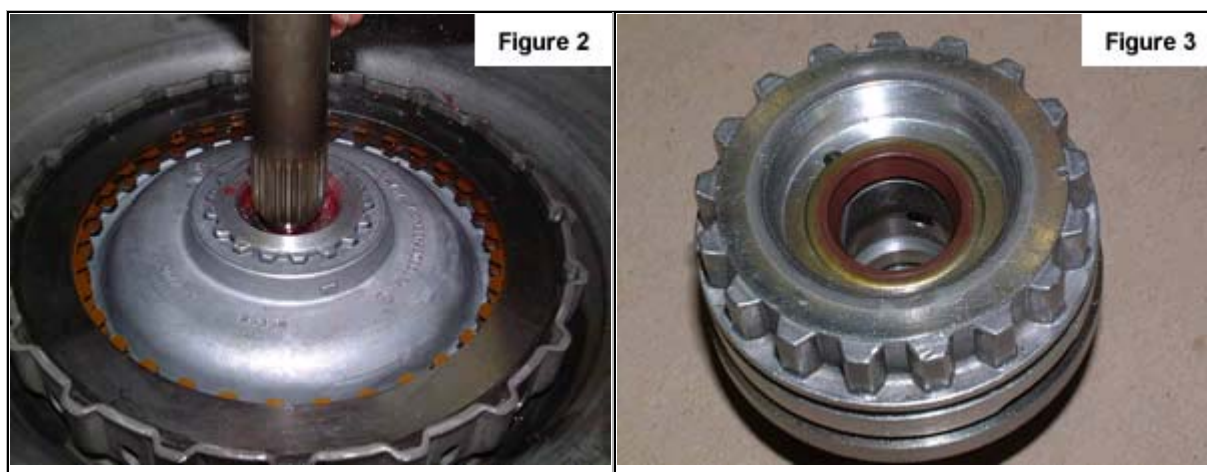
One mating surface is the larger diameter of the input shaft and it measured .660". The other mating surface, the cover tower bore diameter, measured .683". The bore diameter of a good OEM tower measures .662". The difference between the .002" factory intended clearance and the .021" clearance of the worn bore pictured here resulted in a 7.5 gallon per minute (GPM) leak, not to mention both cold stall and TCC shudder issues. This issue was resolved by removing the O-ring/lathe cut seal, blocking the lube bypass passage, and installing a radial lip seal (**Figure 3**).

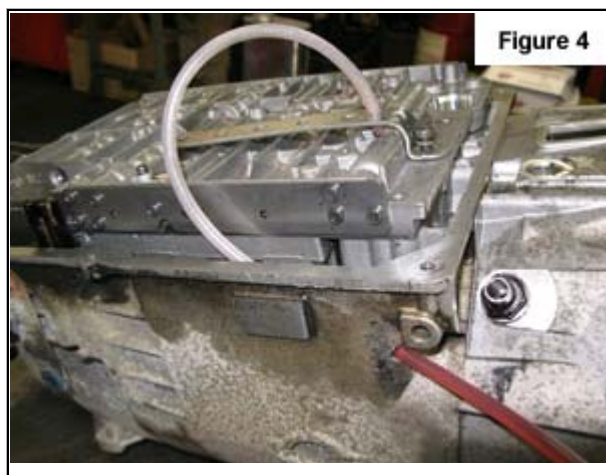
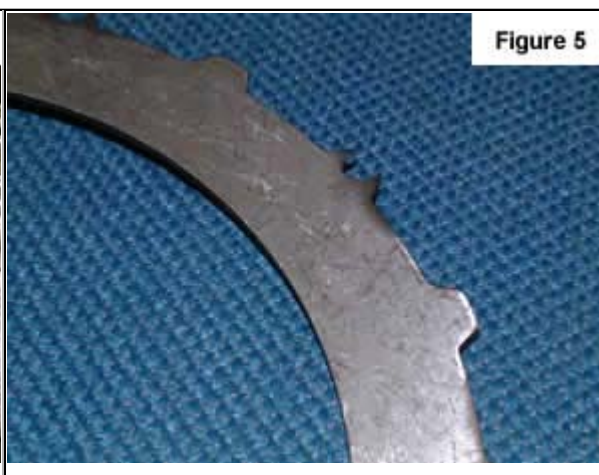
Up to this point there had been no change to the cold stall condition. Wayne wanted a test to verify if cross leak oil was applying the TCC piston. With Bob Warnke's help, Wayne tapped into the exhaust passage at the TCC control valve and routed a hose from that passage to the outside of the transmission case. With the valve in the release position, this circuit is directly connected to the TCC apply oil circuit (**Figure 4**).

A steady stream of fluid would prove that the TCC piston was being hydraulically applied by cross leak oil. No steady stream of oil flowed out of the hose, so the test did not prove what was expected, but one very important piece of information was learned.

As fate would have it, the clear plastic hose that exited the transmission was run vertically upwards. This made the hose act like a stand pipe and, when the engine was started, the fluid rose about one foot up the tube and stayed at that position. This information proved to be critical.

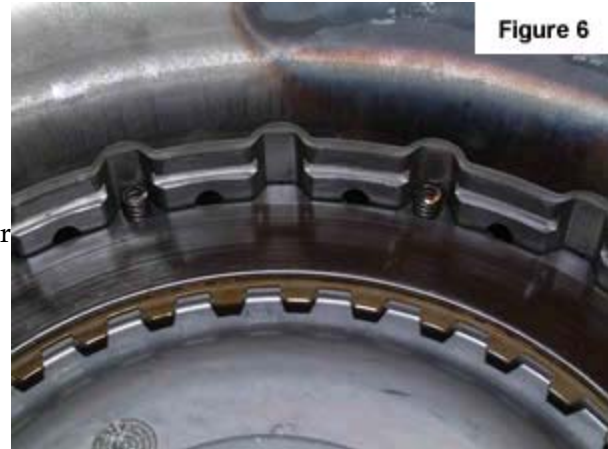
To understand this problem you need to remember two characteristics about the 722.6 TCC design. In a typical single TCC piston setup, oil behind the piston holds the piston off the cover when it is in TCC release. In the 722.6 clutch pack system, apply oil is routed between the cover and the piston on its way to applying the clutch. So first, remember that oil behind the piston, in this case, is for TCC apply. Second, remember that there is no dedicated release oil pressure sent in to keep the clutch from dragging. Release is accomplished by exhausting the apply circuit, allowing TCC charge oil pressure to move the piston to the release position, squeezing the apply oil out of the cavity between the piston and the cover.

The oil rise in the exhaust circuit tube showed that there was a pressure rise in the TCC apply circuit when the engine was started. More specifically, it showed that there was residual oil trapped behind the piston and, when the engine was started, centrifugal force was causing the piston to apply (as well as pushing oil further up the tube.) If there was no residual oil trapped behind the piston, the problem would not exist. Lacking any viable check ball or hydraulic option to purge the residual oil, a mechanical option tried. The middle steel plate in the clutch pack was modified by notching 10 of the 20 O.D. lugs to allow for spring clearance (**Figure 5**).

Ten springs were then added to serve as piston return springs (**Figure 6**) and Taa –Daaaaaa THE VEHICLE WORKED PERFECTLY!
