Testing N2 and N3 speed sensors in reference to battery ground

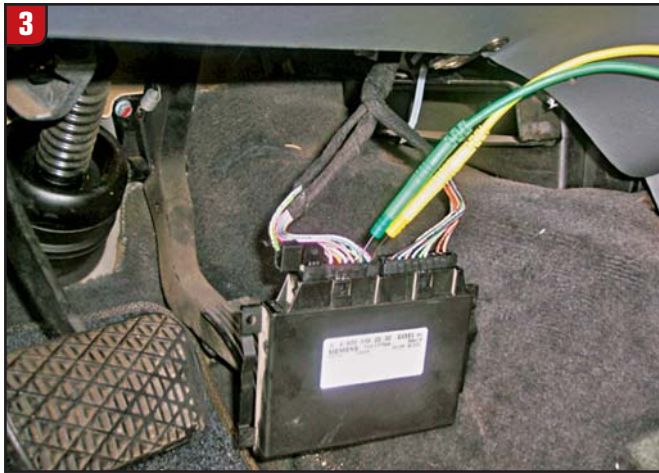
Since the codes were directing us to the N2 and N3 speed sensors again (notice no code 014), we decided to go straight to the horse’s mouth, so to speak; we back-probed the N2 and N3 speed sensors at the TCM (Figure 3).

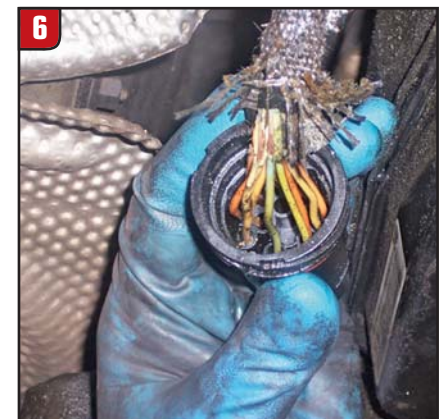
Now the most-likely short in the circuit to battery voltage would be the voltage that the TCM provides to the transmission through pin 6 for the shift solenoids, and since this was an intermittent problem we had to make an educated guess. We know how problematic the transmission-harness connector can be, so we decided to start there. Our hunch paid off (Figure 6).

It appears that the connector did leak transmission fluid into the harness, but it did not get to the TCM. The fluid had caused the insulation to flake off at the bot-
