[PeachParts Mercedes ShopForum](#) > [Technical Information and Support](#) > [Tech Help](#)
How I fixed my duovalve (W210), got my heat back and saved myself \$250!

How I fixed my duovalve (W210), got my heat back and saved myself \$250!

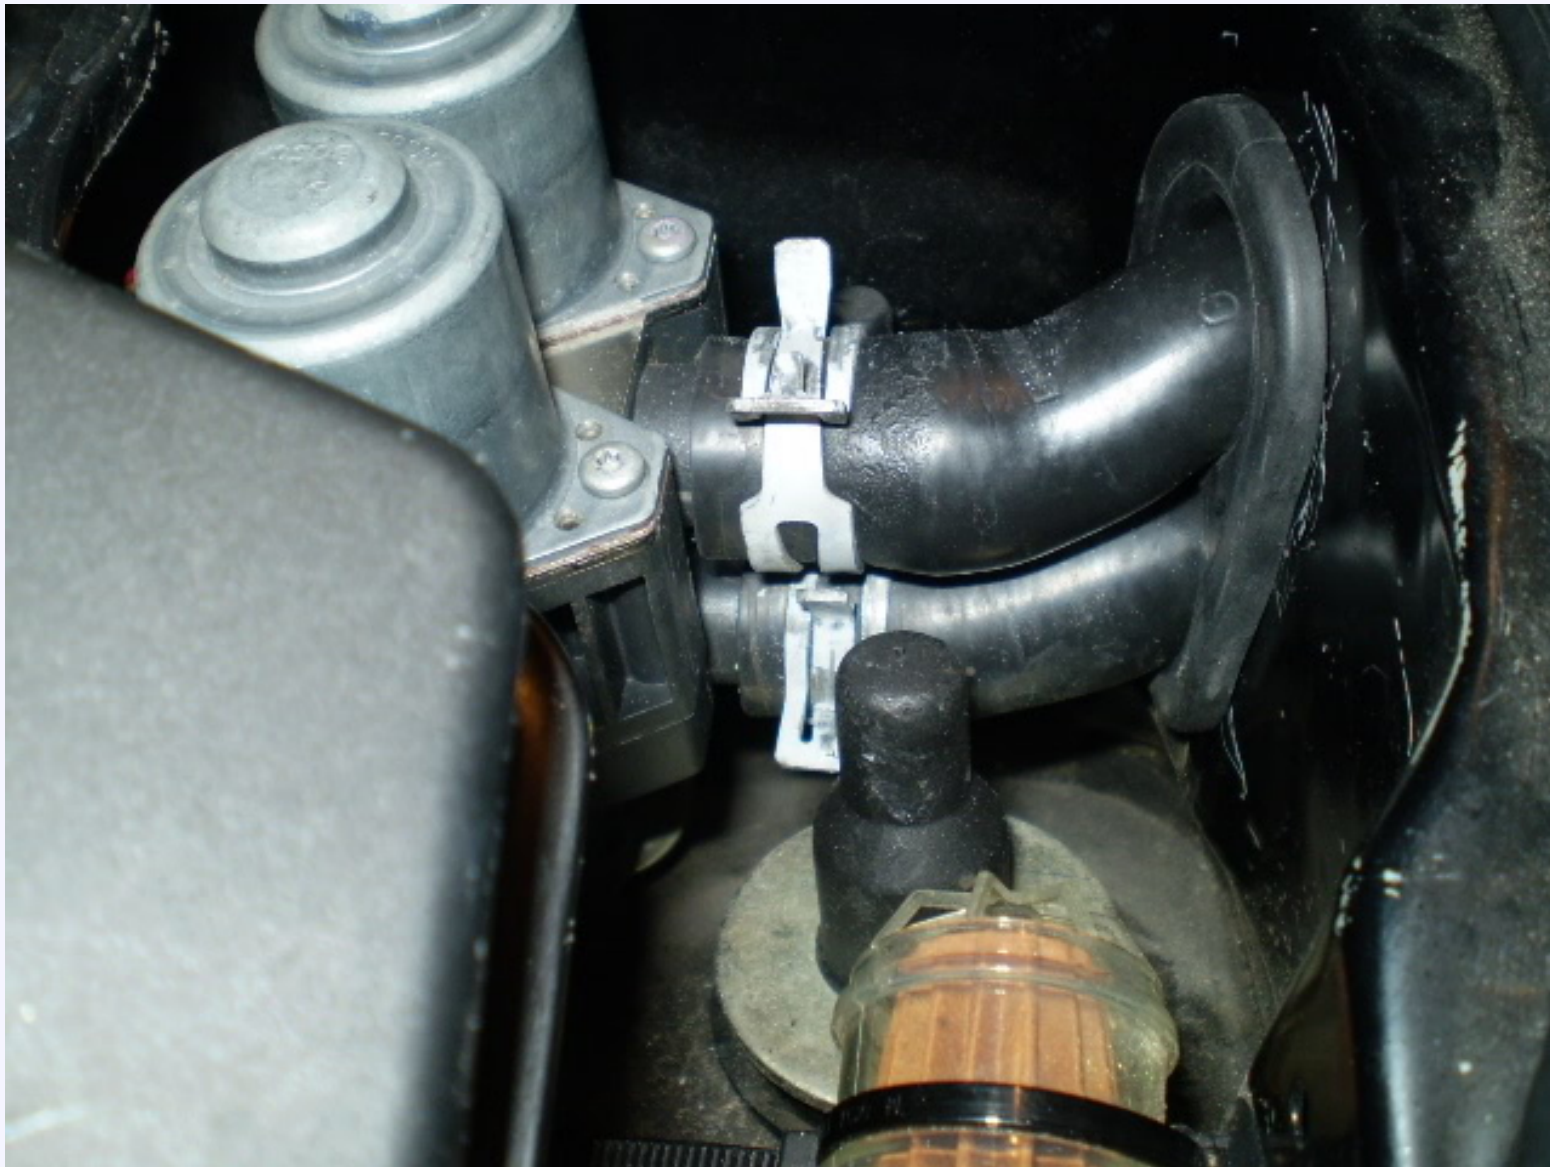
To remove the duovalve, first unlatch the top of the air filter housing and move it aside for better access to the hoses. Then remove the top spring clamp and hose. Next, push the top hose and the large rubber grommet out of the hole in front of the bulkhead.

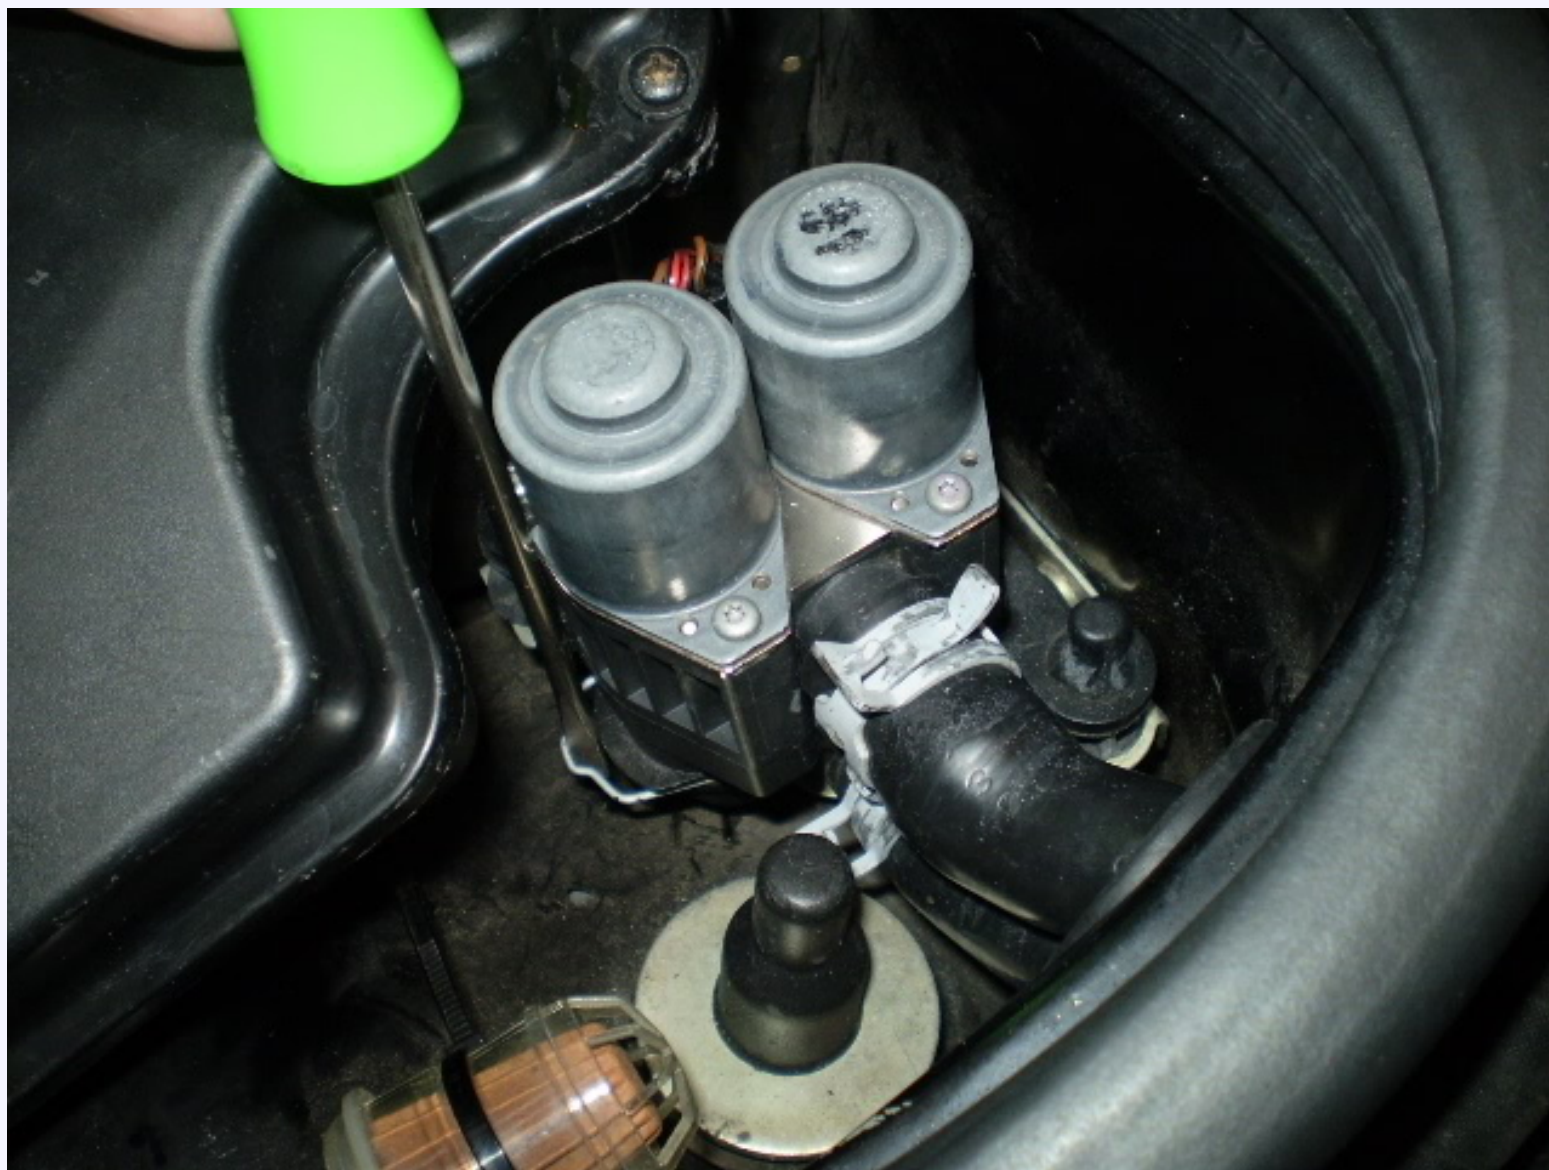
Take a screwdriver and gently pry the lower retaining clips out until they make a small "snap" sound at which point, they'll stay in the out position. There's one on each side.

After the clips are opened, grasp the two metal coil housings and gently wiggle and pull them upward to free the upper assembly from the lower one. You may need to place the tip of the screwdriver on the flange of the bottom piece and gently press downward while pulling up to free the parts. Once the top part is free, unplug the electrical connection and then remove the bottom spring clamp and hose.

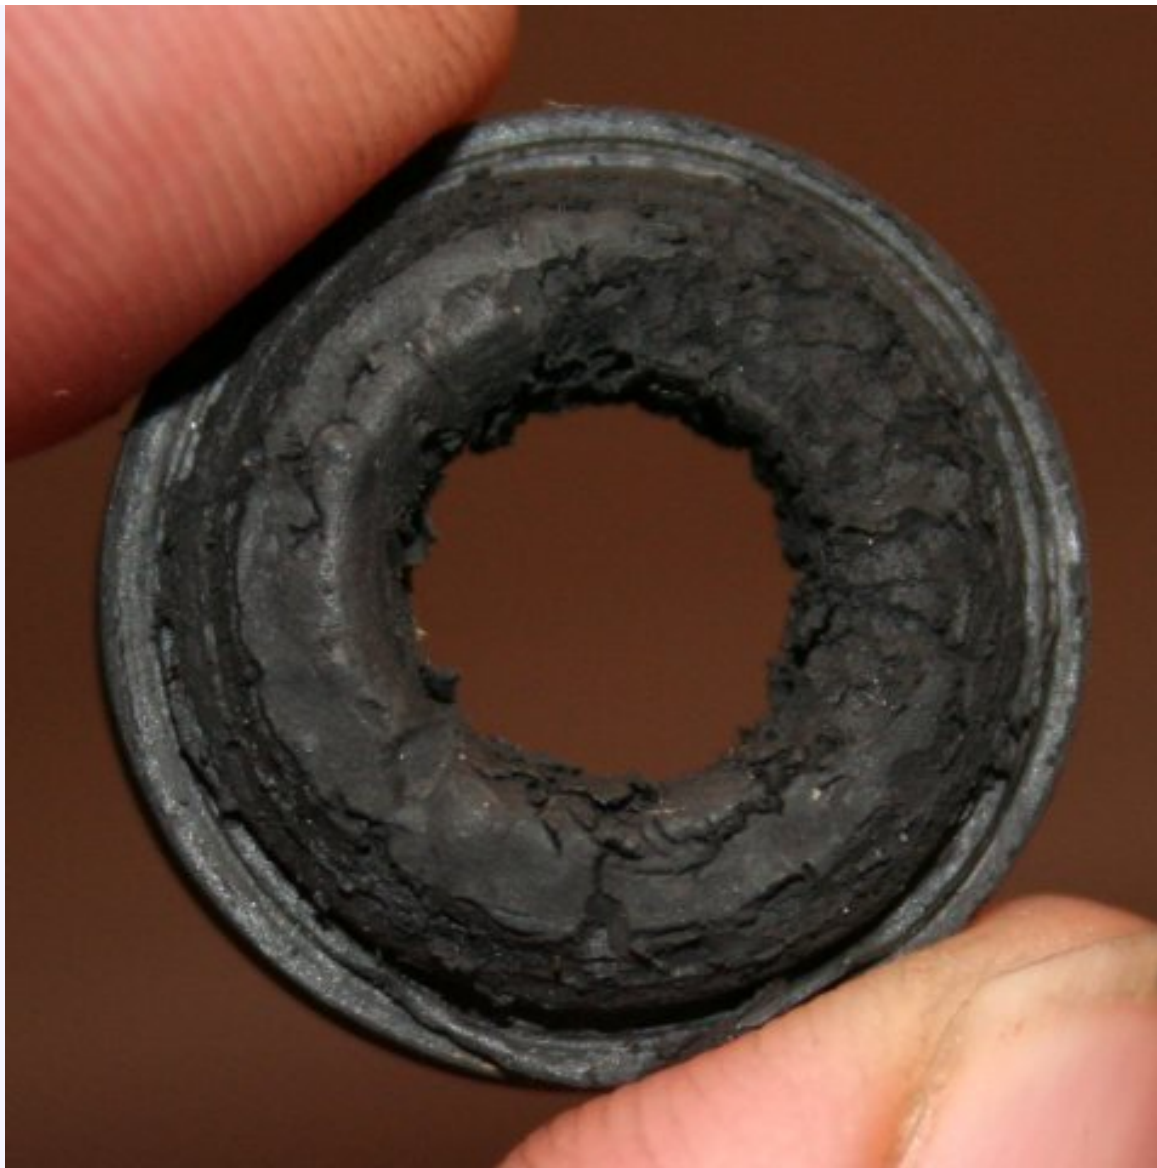
This is a closeup of the valve seal showing the poor shape it's in:

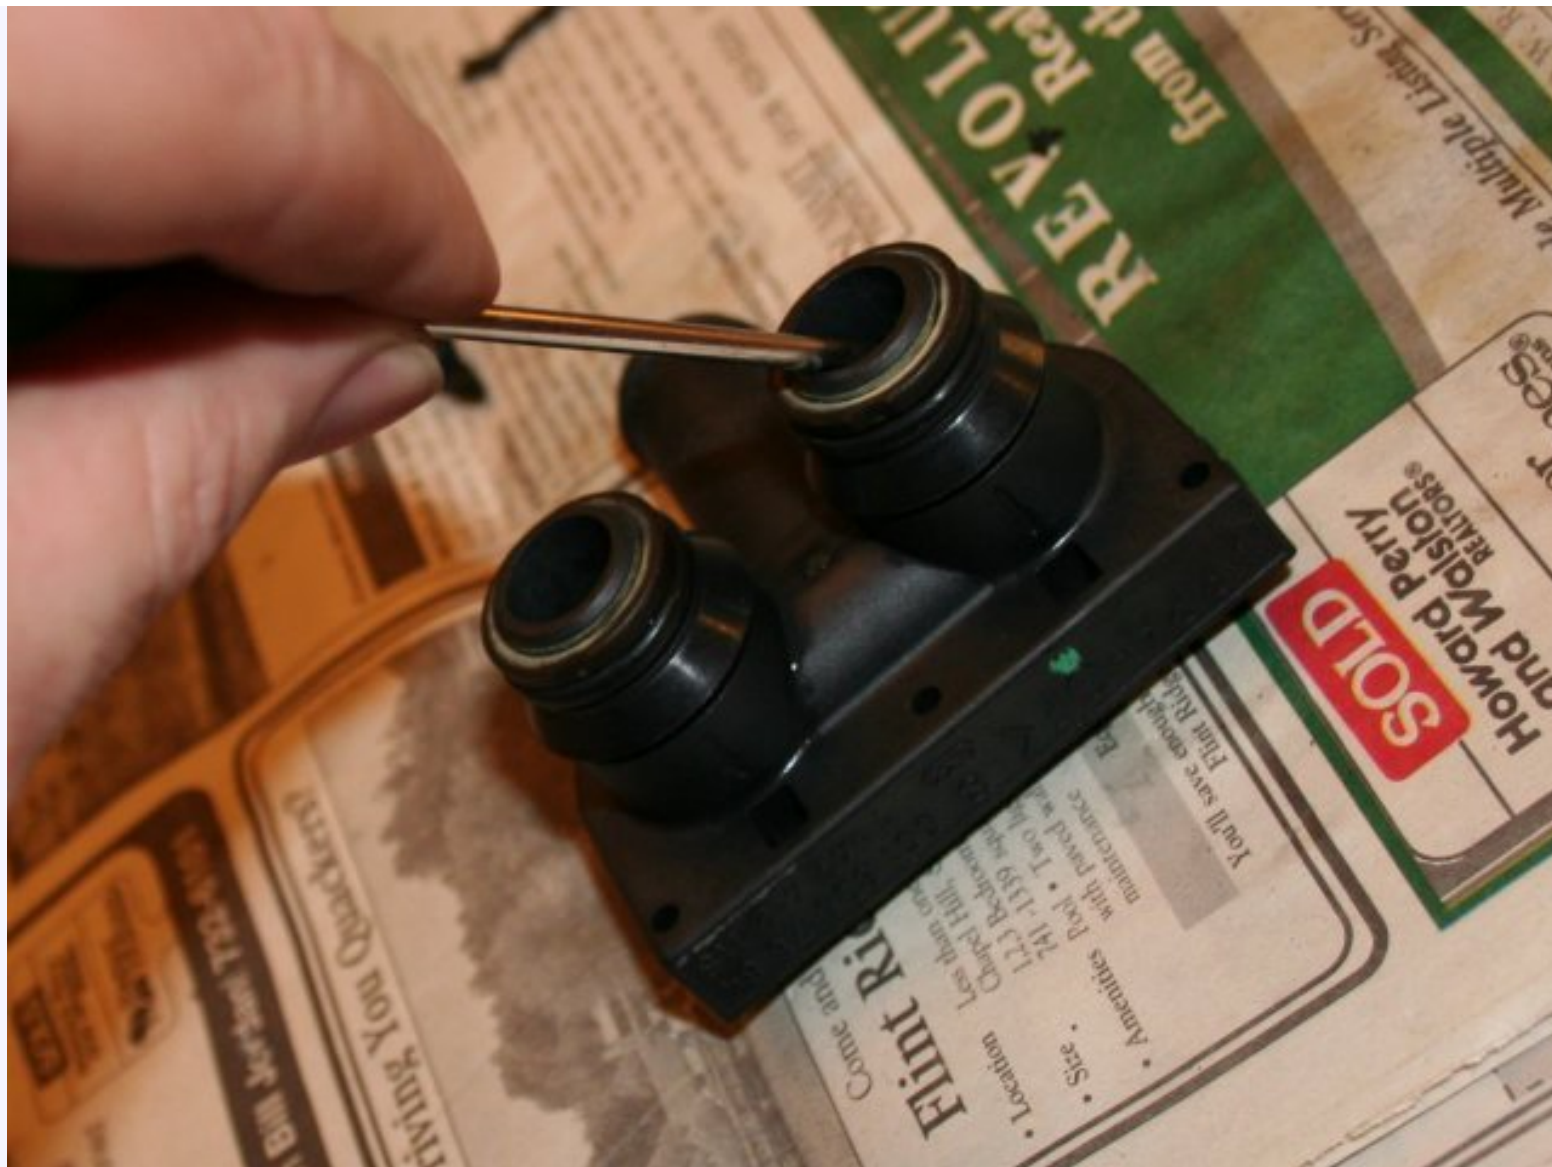
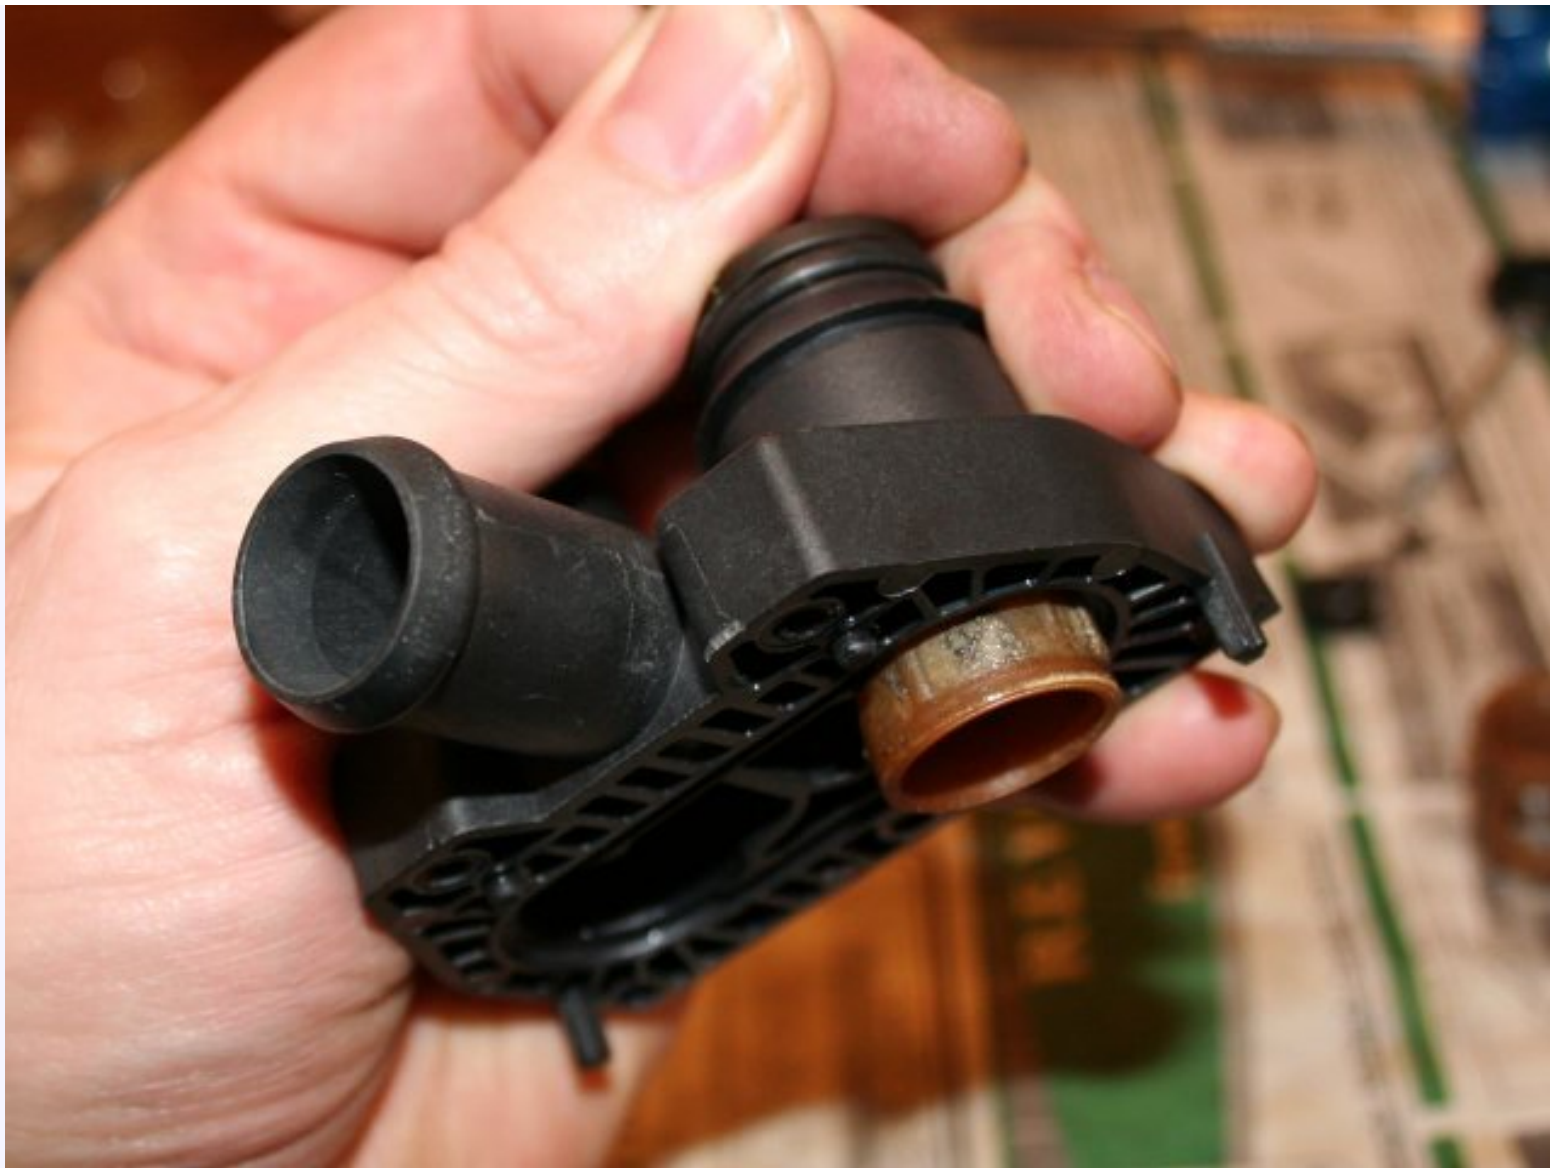
There are two more identical seals in the lower half of the valve. Take a screwdriver, inserted through the lower hole and press against each of the two seals and the brown plastic retaining cylinders. A little bit of force is needed to dislodge them. Once free, you can pull them out by hand and then pry out the rubber seals.

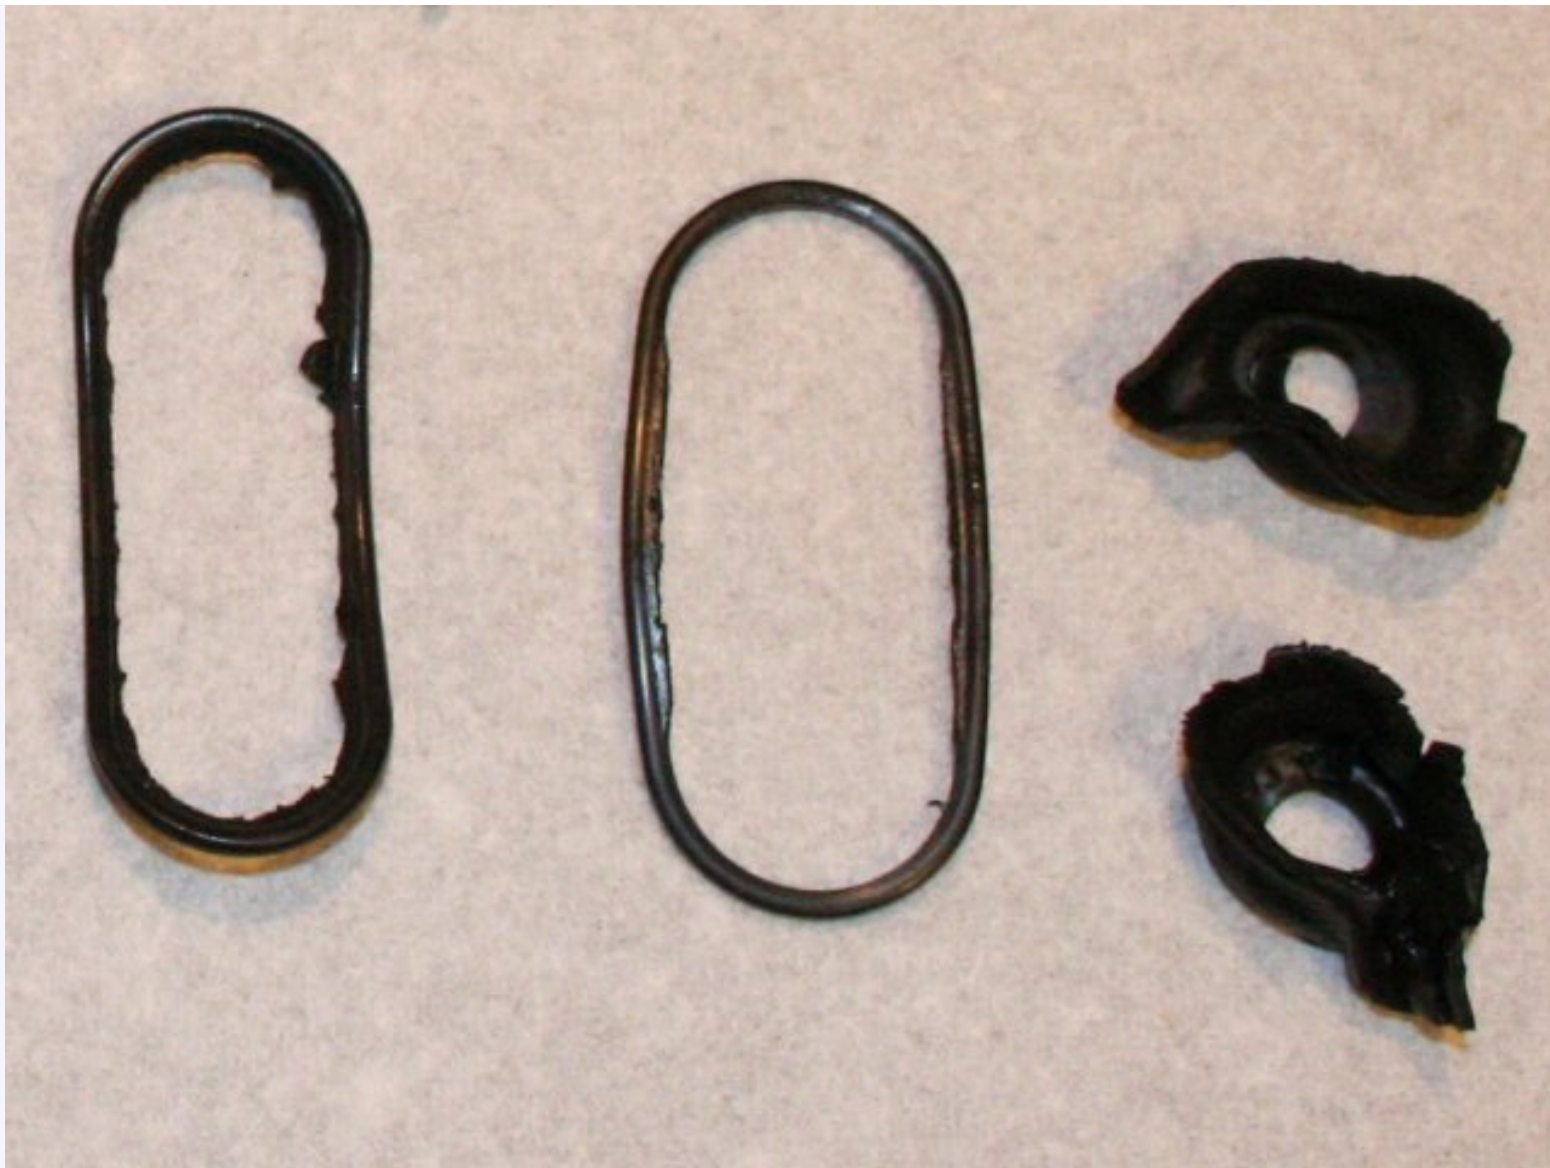
There will also be 2 O-ring seals, one between each section. Depending on the condition of the parts, you may need to do some trimming to make them usable again. I took a pair of scissors and carefully trimmed the excess rubber of in order to re-use them. The two pieces on the right were discarded.
