## Tool for Adjusting the Trigger-points of the D-Jetronic

The tool is intended for checking the adjustment and re-adjusting even heavy worn trigger-points to the original values by simulating the bottom of the distributor-camshaft.

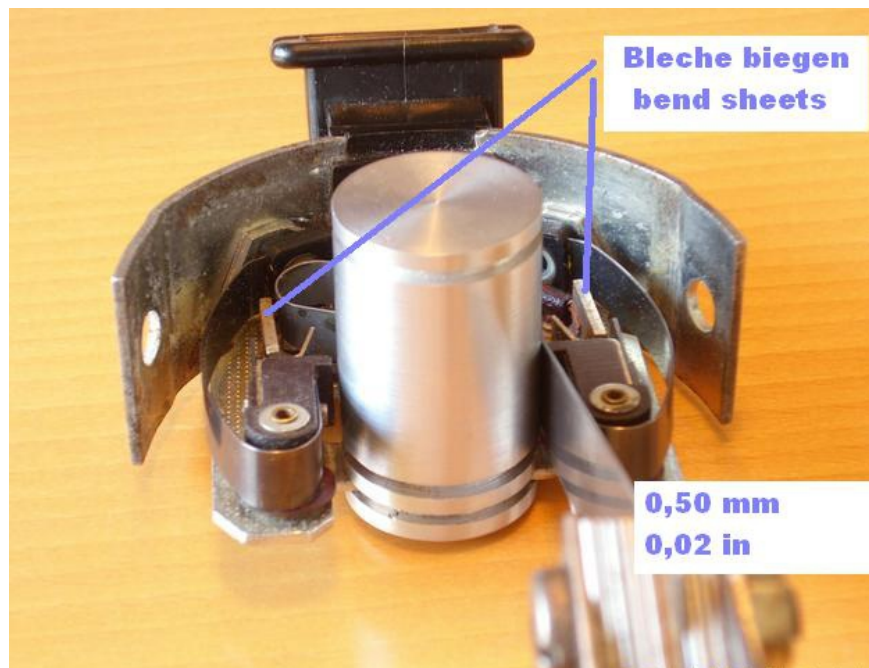
The figure below shows the tool in position (points set type '2').

1. Adjust space between tool and fibre rubbing blocks to 0.02 in (0,50 mm) in this position by bending the sheets of the anvil-plate with flat-nose pliers, checking with a feeler-gauge.
2. By inserting a feeler-gauge of 0.04 in (1,00 mm) instead you can check the points in fully-opened situation. The points gap will be 0.03 in (0,75 mm) if correctly adjusted.

Because there exist base-plates in three different thicknesses, the matching flute has to be chosen (figure!):

- 1 - On the top a flute for base-plates 1.6 mm (Volkswagen, Porsche...?)
- 2 - On the bottom a flute for base-plates 1.5 mm (set with 3 'noses') (Opel, Volvo, Lancia, Fiat, Citroën...?)
- 3 - On the second position from bottom a flute 2.0 mm (Mercedes – V8)

1. The tool has to be pushed into the the trigger-unit all the way up to the stop. Some turning the tool and trying again may help, perhaps a little grease will help. The tool has to fit exactly, therefore the tolerance is minimized.
2. The anvil-plate of the points is mounted insulated, therefore may have some tolerance towards the base-plate. After adjusting one side of the trigger-points-pair, you have to control the opposite side. Maybe you have to re-adjust this a couple of times.
