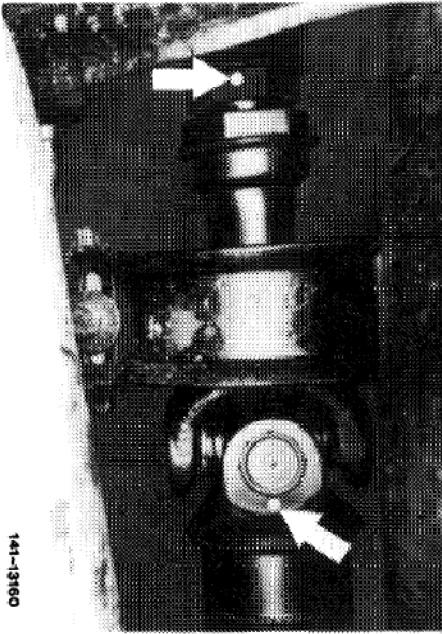
141-13160

Uresei engine, as well as with engine 1U4, mark front and rear propeller shaft with vibration eliminator in relation to each other (refer to arrows). Remove front propeller shaft in forward direction and rear propeller shaft in rearward direction.

For lack of space, removal of complete propeller shaft toward the rear is not possible on vehicles with vibration eliminator.

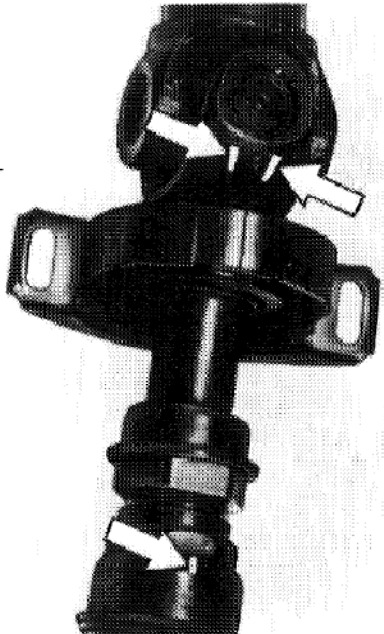
141-28660

11 On all vehicles starting August 1982 the front and rear propeller shafts are pertinently identified.

The front shaft is provided with a hump and the yoke of the rear shaft with two-arrow-like humps (arrows). The hump of the front shaft should be located between the two arrows on yoke (arrows).

Note: Identification has already been available on propeller shafts prior to August 1982, but not been taken into consideration during assembly. For this reason, propeller shafts on which the marks are not in agreement must be identified prior to removal and the two parts must be plugged together again in accordance with this identification.
