MODEL 163.154 #A as of 000001 up to 014254

i Vehicles within the Effective Serial Number Range, must have the following work performed during next scheduled maintenance or service. Install pinch nut to ensure proper tightening torque of rear stabilizer bar mounting.

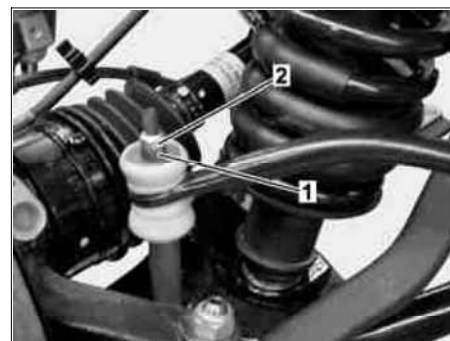
P32.35-2001-01

Installation		
1	Retorque nut (1) on rear stabilizer bar connecting rod bolt	Nm	*BA32.20-P-1001-04F
2	Install pinch nut (2) on top of previously torqued connecting rod bolt nut		
3	Counterhold connecting rod bolt nut (1) while torquing pinch nut (2)	Nm	*BA32.20-P-1003-04F
4	Repeat for opposite side

Number	Designation		Model 163
BA32.20-P-1001-04F	Nut, connecting rod to torsion bar	Nm	28
BA32.20-P-1003-04F	Pinch nut, connecting rod to torsion bar	Nm	28
