MODELS 163.113 /128 /136 /154 /157 /172 /174 /175

Vehicle illustrated up to 31.8.98

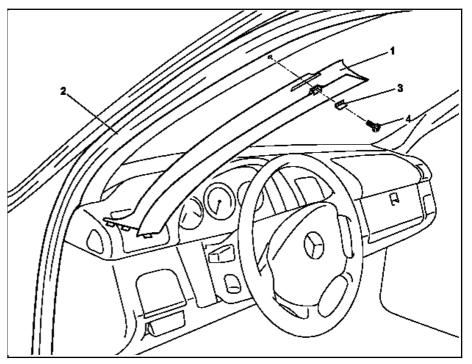
P68.30-0537-06

- A-pillar paneling Door rubber seal
- 2
- 3 Cover cap
- Bolt

XX	Remove/install	
1	Remove door rubber seal (2) in area of A-pillar	
2.1	Remove cap (3)	Up to 08/98.
3.1	Unscrew screw (4)	Up to 08/98.
4	Remove A-pillar paneling (1)	The paneling is fastened in the instrument panel at the bottom with lugs and will be fastened with a clip at top as of 09/98. Installation:Replace clip SLong wedge *115589035900
5	Install in the reverse order	i On vehicles up to 08/98, on which a new paneling should be installed, the upper area of the fixing opening at the top of the A-pillar must be enlarged so that the clip retainer of the paneling can be installed in the A-pillar.
