## DIY 722.6 Transmission Conductor (Electrics Kit) Plate

My 1997 E320 with 100k miles finally went into (electric) Limp Home mode (2nd and reverse only). I pulled the EGS (ETC – Electronic Transmission Control Module) codes and found 013, 108, and 109. Code 013 is N3 speed sensor malfunction, 108 is a stored (pending) code for N2 speed sensor malfunction and 109 is a stored (pending) code for N3 speed sensor malfunction. So all the codes are pointing toward the two speed sensors on the conductor plate, which is on top of the valve body.

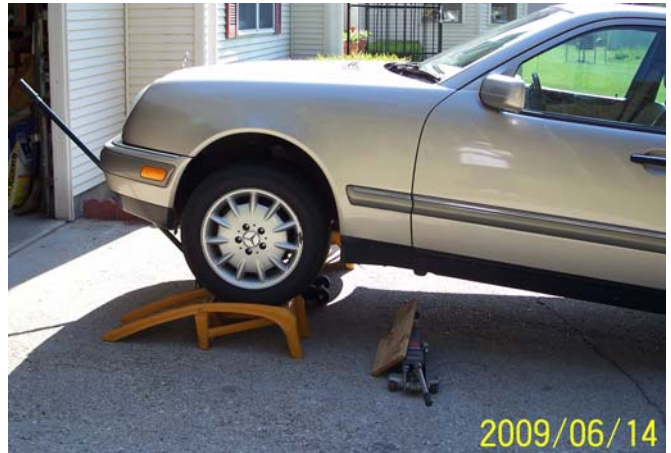
1. Raise the car. Make sure you securely raise the car. As you can see, I made it redundant here. I used some heavy duty car ramps (see the braces) and a 3.5 ton jack at the front chassis listing point. Engage parking brake and also choke the rear wheels. You may find it odd that I drove car up back onto the ramp, ☺. I actually used that large jack to raise the front and then slid the ramps under the tires.

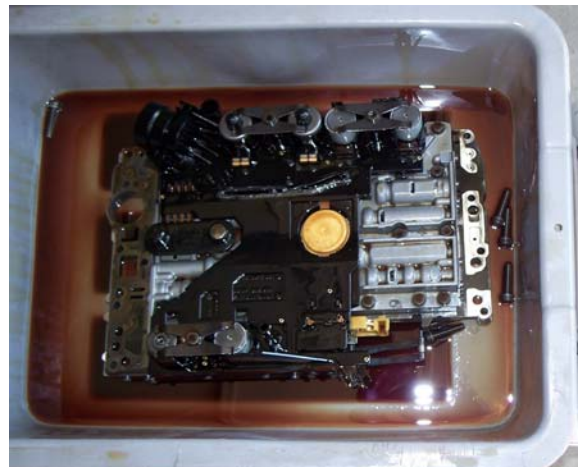
4. Remove the oil pan and the filter. (Again See G-AMG's excellent DIY on this.)
5. Now remove ten (10) T-30 Torx screws that secure the valve body to the transmission. Remove the valve body from underneath. The valve body is quite heavy so be prepared to eat some spinach in the morning. ☺ The picture to the right is the valve body (with the conductor plate). In this picture, you should see six (6) solenoids. They are the round shaped things: four (4) on top of the picture, and two (2) on the lower-left of the picture. They are in pairs of two (2). Each pair is secured by a leaf-spring and a T-30 torx screw. The lengths of the screws are different and the solenoids are also different so you need to layout the setup exactly as assembled so as not to mix things up.

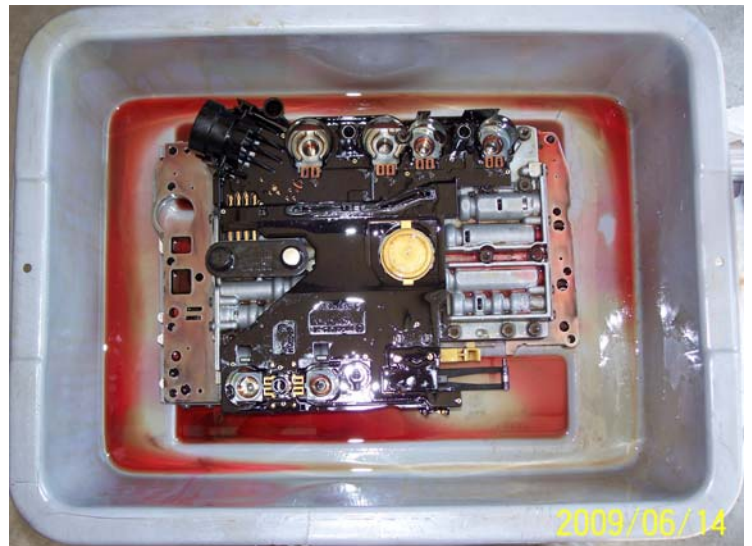
6. Remove the torx screws, the leaf springs and the solenoids from the valve body (with the conductor plate in place). Here is what you see. Now note that where the solenoids were before are just six (6) holes and some electric contacts (each solenoid has two electric contacts). The round black thing on the top-left corner is where the infamous 13-pin connector plugs into. That 7-mm screw goes into the center of this black part.

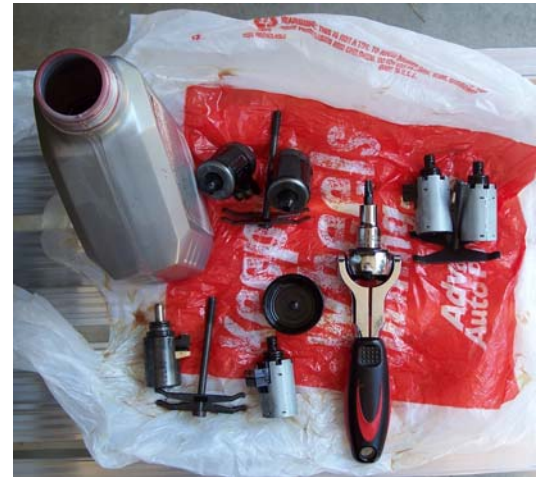
7. Here is a picture of the removed solenoids, leaf springs, and the torx screws. You see I put them as if they were on the valve body so there will be no confusion. The rotor-head ratchet is a speedy device as it can be used as a screw driver. Also note the bottle of the Mobil 1 synthetic ATF (DEX III). LOL, I am using it as a cleaner for this purpose. I changed the ATF (Mercedes 236.12 fluid) and filter about 25k mile ago and it was pretty clean then. It is very clean today. There is no graphite residue anywhere on the valve-body and also in the oil pan. This will be my last fluid/filter change for this transmission unless it just keeps running.

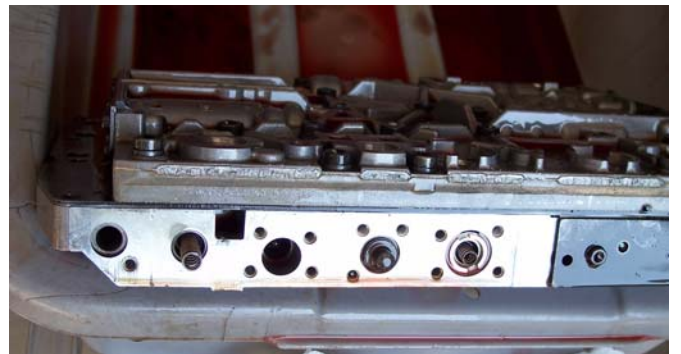
8. Now you can remove the conductor plate (black plastic) from the valve body (shiny aluminum). There is only one little catch on the transmission fluid temperature sensor. Just bend it a little and remove the conductor plate. You cannot miss it. With the conductor plate out, I removed the plate that covers the four valve springs (a dozen also small torx screws holding it) and examined the pressure control valve spring and other springs. My spring was not broken but I replaced it anyway. Since I ordered three of these springs, I have two left. Let me know if you need one.
