D. Model 126 sedan and coupe

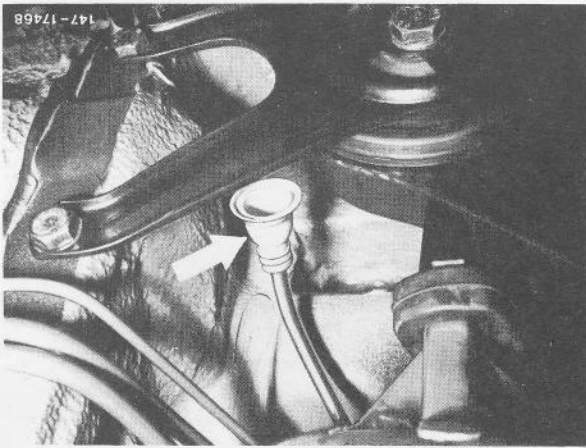
Positive and negative venting of fuel tank proceeds via vent line (64), with a protective sleeve (arrow) attached at its end.

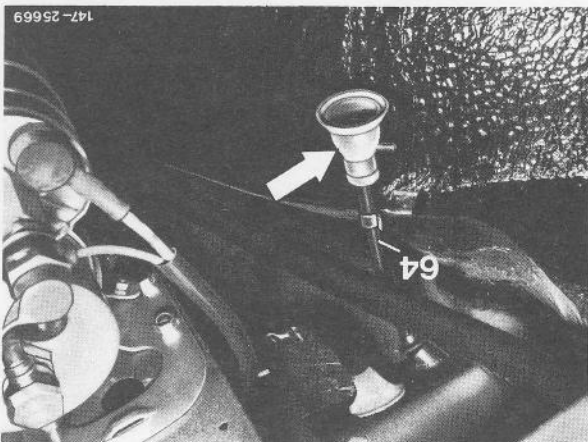
The vent line (64, arrow) leads from expansion tank (55) through rear floor in outward direction. Positive or negative venting of fuel tank proceeds by way of this line. A protective sleeve (arrow) is attached at end of vent line.
